# *HomePro Inspections of RI*

**Confidential Property Inspection Report**

**123 Main, Anywhere, RI 02874**  
**Inspection prepared for: New HomeBuyer**  
**Real Estate Agent: NONE -**

**Date of Inspection: 11/2/2015 Time: 3:00pm**  
**Age of Home: 1986 Size: 1418**  
**Weather: Clear, Warm**

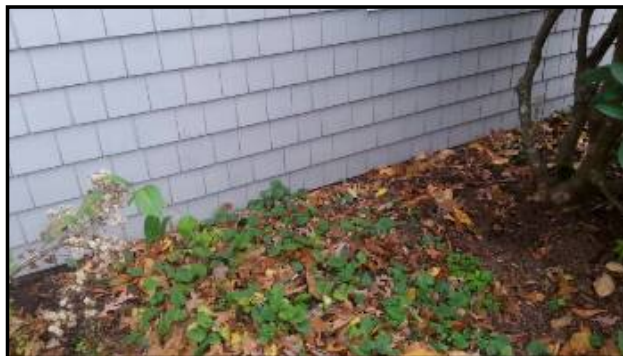
1.1. Siding material at exterior areas of home is in contact with the ground or is not within the proper **clearance** distance from the ground. Ground clearances of 6 to 8 inches is recommended to prevent deterioration, water intrusion, and pest/insect entry points. Changing the finished grade and/or landscaping is not an option because it would create a poor drainage condition. One option for repairs would be to install **flashing** between the ground and siding material. This will help protect the material from moisture. Another option would be to install a 6" to 12" band of **gravel** to help promote drainage.

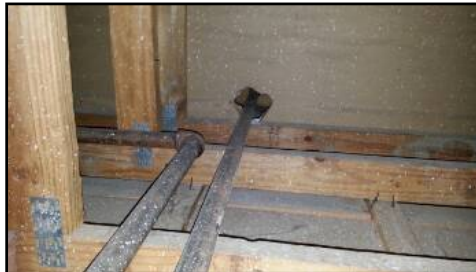
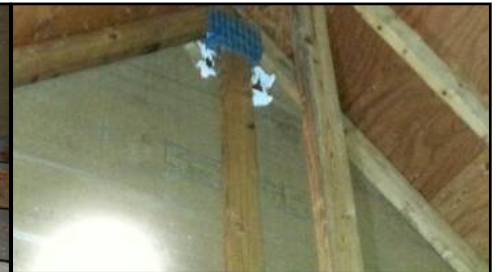
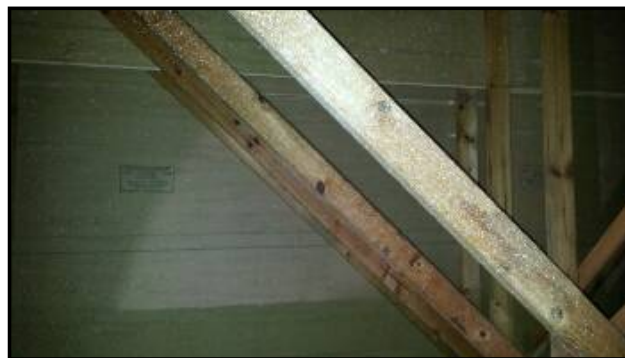
1.1. The wall at family room is damaged (corner bead).

1.2. The wall between the attached garage and the abutting home has a breached **fire stop**. Openings, seams and voids in the wall/ceiling areas need to be proper sealed. This is considered improper and is a safety issue until corrected.

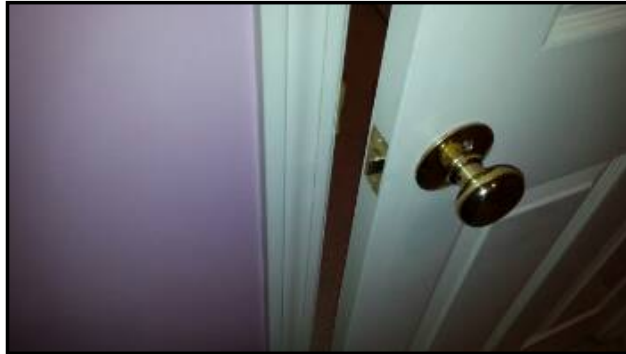
##### 4.1. Master bedroom door does not latch

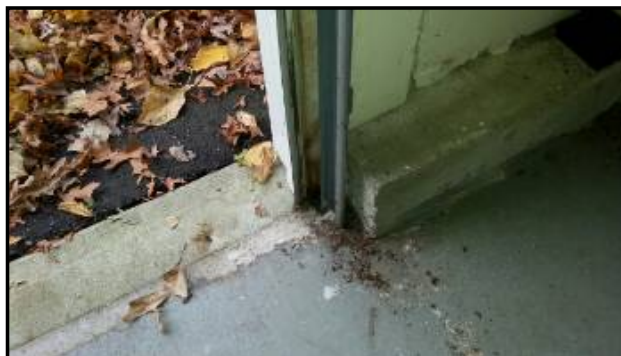
10.1. Electric sensors are not installed at overhead garage door(s). Recommend installing sensors for additional safety measures. Some older style openers are not compatible for sensors and if this is the case a new opener should be considered.

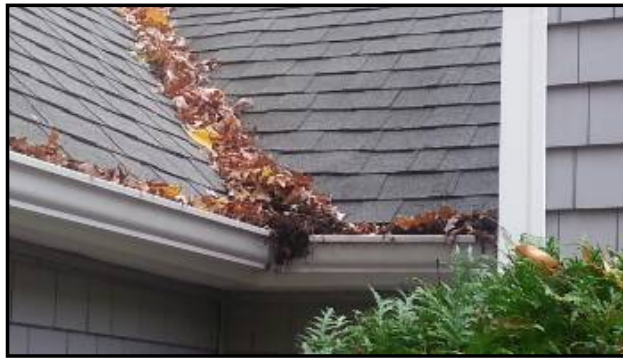
- 2.1. ----- GUTTERS -----
- 2.2. Gutters should be kept clear of debris
- 2.3. ----- DOWNSPOUTS -----
- 2.4. Downspouts should be kept clear of debris
- 2.5. Recommend extending downspouts at least 3' from structure to help keep water away from **foundation**.

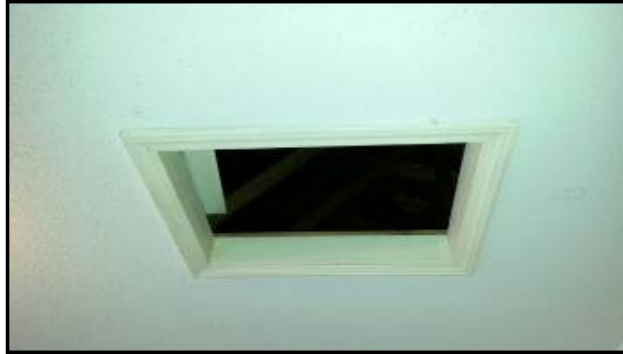
3.1. The attic **insulation** is R-19+/-, which was a common insulation goal in the past. Today's building standards require a minimum of R-38. Adding additional insulation will provide greater comfort to the occupants and savings in energy costs should be achieved.

3.2. Recommend evaluation of attic insulation by RISE. Contact information is located in the Home Inspection Binder

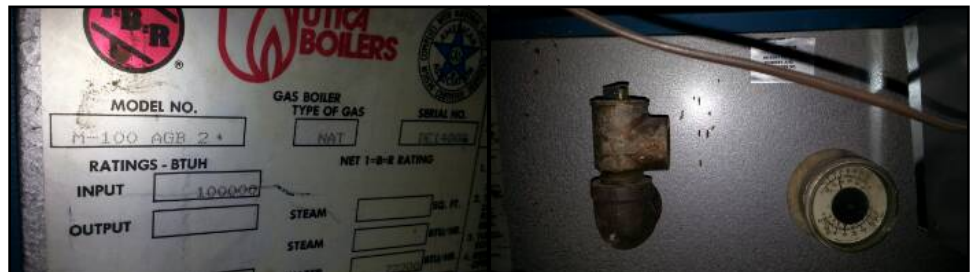
Pressure Relief Valve

1.8. There is no down piping at the **pressure relief valve**. Down piping should be installed and extended down to within 6" to 8" from the floor

1.9. Pressure relief valve is leaking. Recommend Service

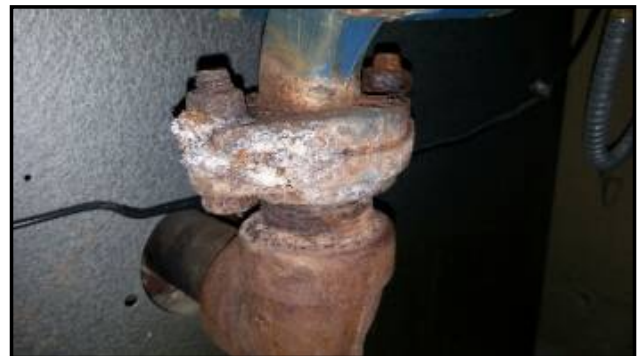
Circulator

1.11. There is heavy corrosion at the circulator. Recommend service.

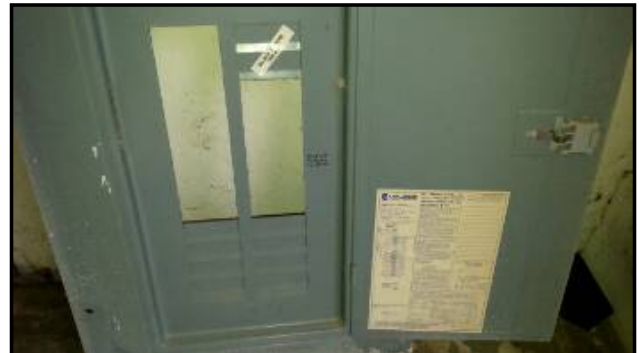
#### 2.1. Panel is partially labeled

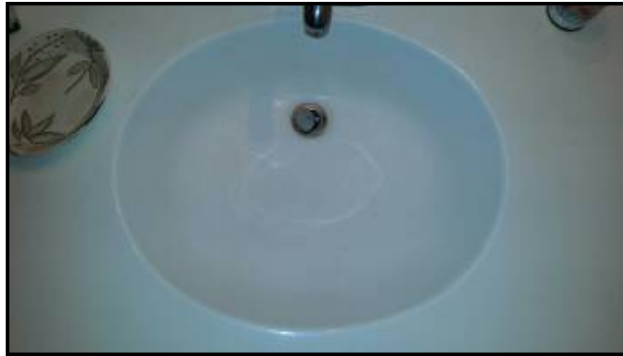
3.1. Hallway bathroom sink does not have an overflow

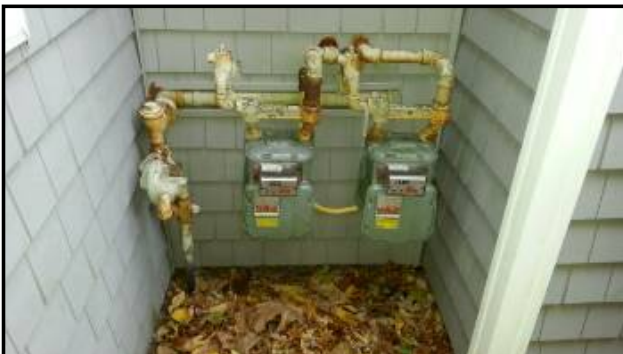
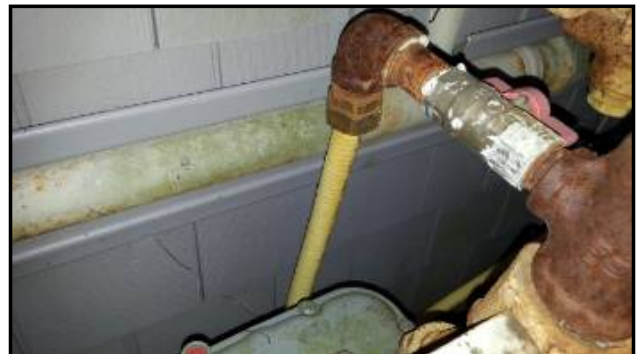
4.2. There is Corrugated Stainless Steel Tubing (CSST) present at the . There is not a bond present at the manifold and is considered improperly installed. A bond is needed to help protect the CSST from lightning strikes directly or indirectly that could cause arcing to occur resulting in possible holes in the CSST. There has been a recent Class Action Lawsuit regarding all manufactures of CSST and all manufactures have come to an agreement that **bonding** is necessary. This is a small repair.

4.3. There is Corrugated Stainless Steel Tubing (CSST) present at the gas meter (fireplace). There is not a bond present at the manifold and is considered improperly installed. A bond is needed to help protect the CSST from lightning strikes directly or indirectly that could cause arcing to occur resulting in possible holes in the CSST. There has been a recent Class Action Lawsuit regarding all manufactures of CSST and all manufactures have come to an agreement that bonding is necessary. This is a small repair.

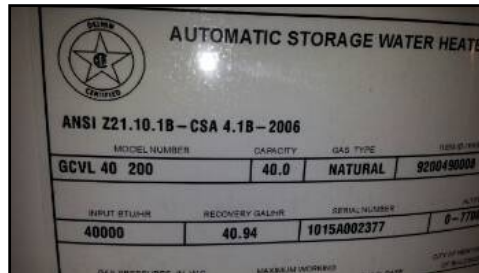
1.4. Drip leg/Sediment trap is missing at gas line to water heater. Drip leg should be 3" minimum. This can cause damage to the unit and shorten the lifespan of the unit.

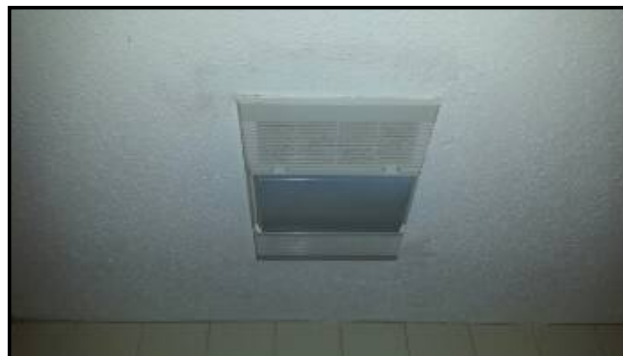
1.1. The exhaust fan at master bathroom operates loudly

1.2. The exhaust fan(s) at all bathrooms is vented out the sidewall.

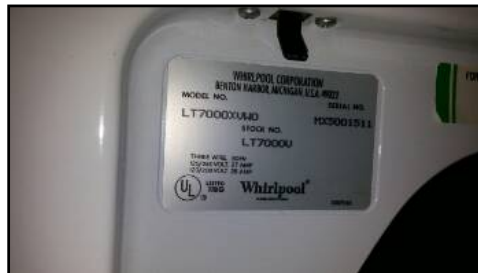
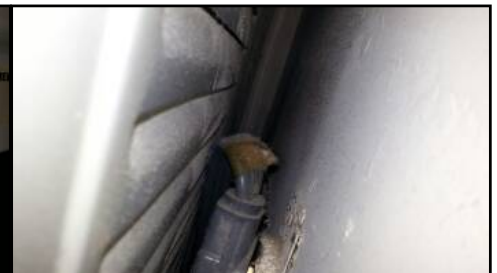
3.8. The dryer vent is not fully visible. Sections are in close to the wall behind laundry area and in the attic. .

3.7. Dryer - Recommend rigid 4" chimney vent pipe for exhaust
