# *HomePro Inspections of RI*

**Confidential Property Inspection Report**

**123 Main, Anywhere, RI 02874**  
**Inspection prepared for: New HomeBuyer**  
**Real Estate Agent: NONE -**

**Date of Inspection: 11/2/2015 Time: 3:00pm**  
**Age of Home: 1986 Size: 1418**  
**Weather: Clear, Warm**

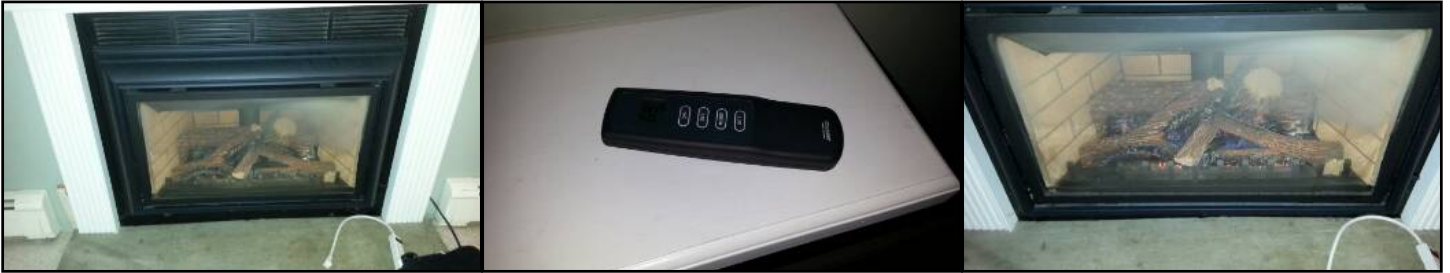
##### 7.1. 1 Gas fireplace(s) present

##### 7.2. Fireplace operated by remote. Fan unit comes on automatically when fireplace heats up

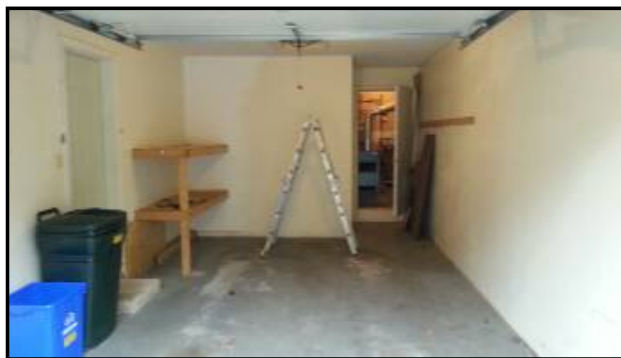
8.1. Limited inspection access due to garage finish

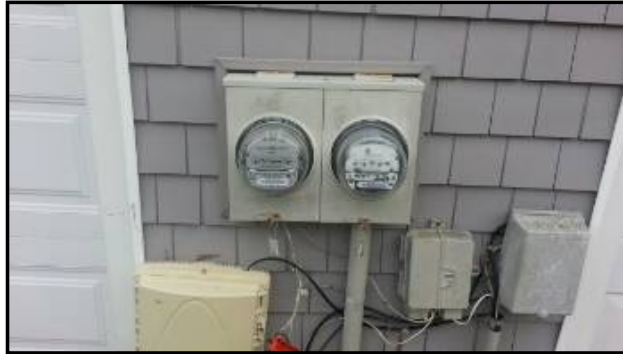
#### 1.1. The meter is located at front of home

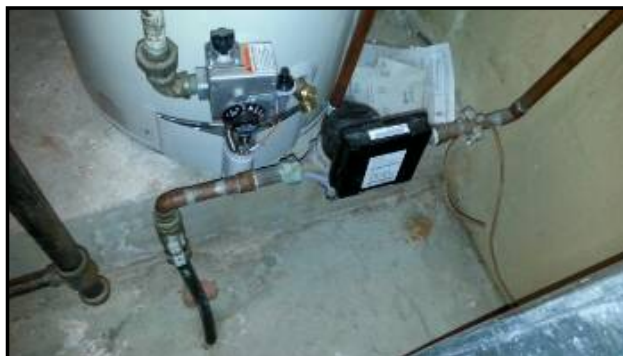
1.1. The main water **shutoff valve** is located at utility room.

1.2. There is a fire hydrant within 500' of the structure. Buyer should notify insurance carrier as this could result in a rate reduction
